08/31/88 Delta

Official Accident Report Index Page

Report Number	NTSB/AAR-89/04
Access Number	PB89-910406
Report Title	Delta Air Lines, Inc. Boeing 727-232, N473DA, Dallas-Fort Worth International Airport, Texas August 31, 1988
Report Date	September 26, 1989
Organization Name	National Transportation Safety Board Bureau of Accident Investigation Washington, D.C. 20594
WUN	4965A
Sponsor Name	NATIONAL TRANSPORTATION SAFETY BOARD Washington, D.C. 20594
Report Type	Highway Accident Report August 17, 1988
Distribution Status	This document is available to the public through the National Technical Information Service, Springfield, Virginia 22161
Report Class	UNCLASSIFIED
Pg Class	UNCLASSIFIED
Pages	135
Abstract	This report examines the crash of Delta flight 1141 while taking off at the Dallas-Forth Worth, Texas on August 31, 1988. The safety issues discussed in the report include flightcrew procedures; wake vortices; engine performance; airplane flaps and slats; takeoff warning system; cockpit discipline; aircraft rescue and firefighting; emergency evacuation; and survival factors. Recommendations addressing these issues were made to the Federal Aviation Administration, the American Asso

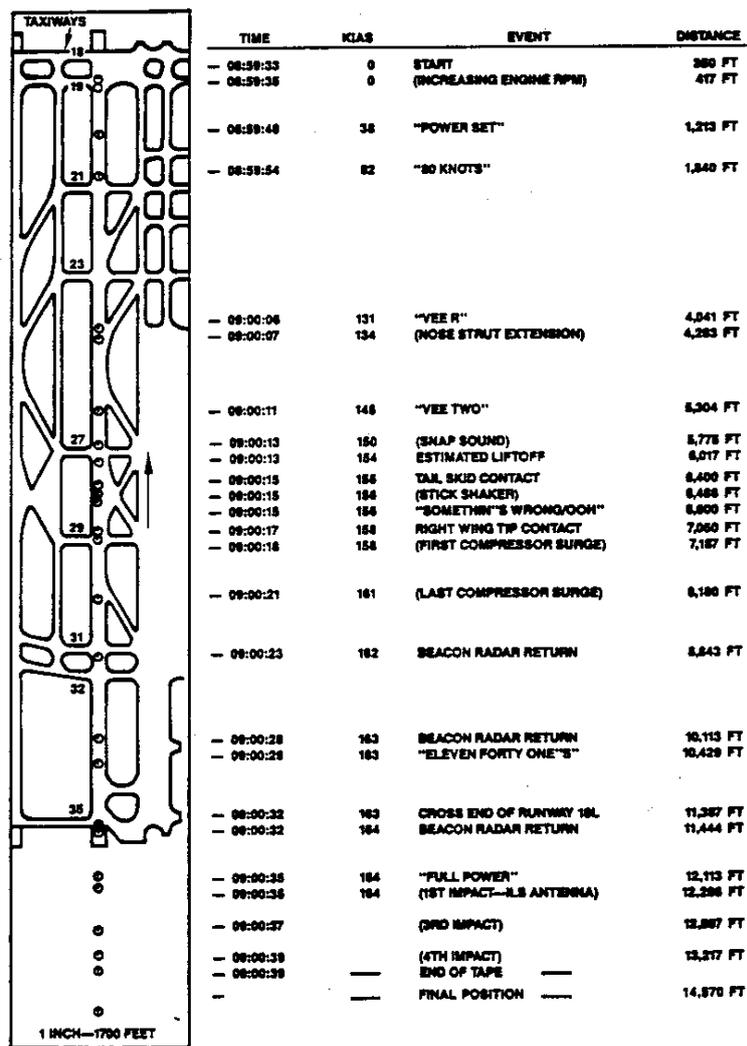
Figure 5.-- Flight 1141 takeoff events.

The first impact mark was made by the tail skid contacting the runway centerline and a runway centerline light between taxiways 27 and 29, at a distance of approximately 4,990 feet prior to the departure end of runway 18L ([see figure 5](#)). About 650 feet from this point, the right wing tip struck the right side of the runway near taxiway 29, approximately 4,340 feet prior to the departure end of runway 18L. The taxiway markers for taxiways 31 and 32 were found knocked over, but they did not exhibit any impact damage. Additionally, the grass was found to be scorched between the end of the runway and the ILS antenna. Approximately 5,300 feet from the point of the right wing tip runway contact, and approximately 900 feet beyond the departure end of runway 18L, the airplane impacted and destroyed the ILS localizer antenna. From this point and beyond, airplane components such as the right wing tip and portions of the right inboard and outboard ailerons began separating from the airplane.

After first impacting the antenna installation, the airplane remained airborne for an additional 400 feet, then struck the ground with the main landing gear wheels which produced a 350-foot linear ground depression. The airplane then traversed a ground depression that was approximately 150 feet wide and 16 feet deep. As the airplane crossed the depression, it impacted the ground on the far side. The airplane track then began to gradually swerve to the right of the extended runway centerline. This portion of the wreckage track was approximately 800 feet long.

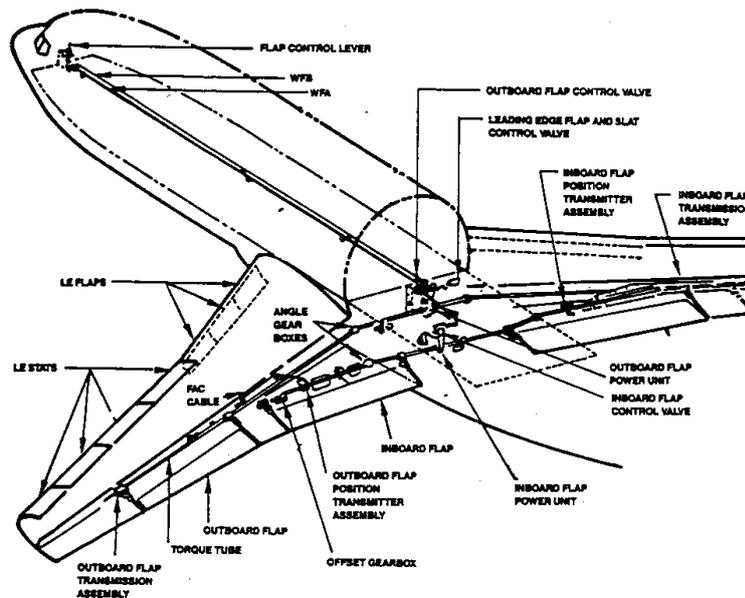
Figure 7.--Trailing edge flap system.

Trailing Edge Flap System.--The flap control mechanism in the cockpit area was found in the flap up position. (See [figure 7.](#)) The mechanism was intact and functional. The flap handle spring tension was normal. The flap control cables were attached, and continuity was established to the forward fuselage break. From the fuselage break, further continuity of the cables was established to the outboard flap control valve located at the forward wall of the right wheel well. Movement of the cables at the fuselage break produced a corresponding movement of the outboard flap control valve input linkage.

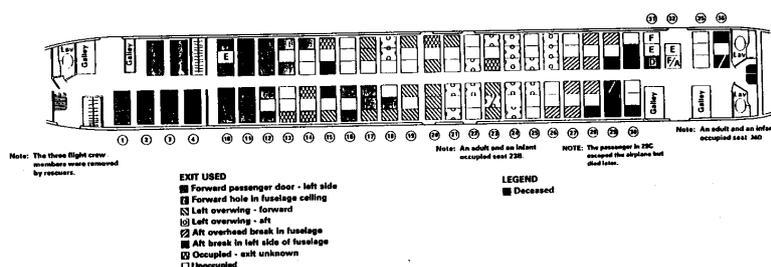
Figure 8.--Configuration of B727-232 and escape routes used.

The investigation found that although the fuselage had separated in several places, the occupiable volume of the cabin was not substantially compromised. Passengers generally stated that impact forces were not severe. Further, the cause of deaths of the passengers in the aft section of the cabin were attributed to smoke inhalation and fire rather than impact injuries. Exit from the aft cabin was hampered by the fire that impinged on the right side of the airplane. Exit from the mid and forward cabin was through breaks in the fuselage and through the left side exits, except for the left aft service door which was not opened.

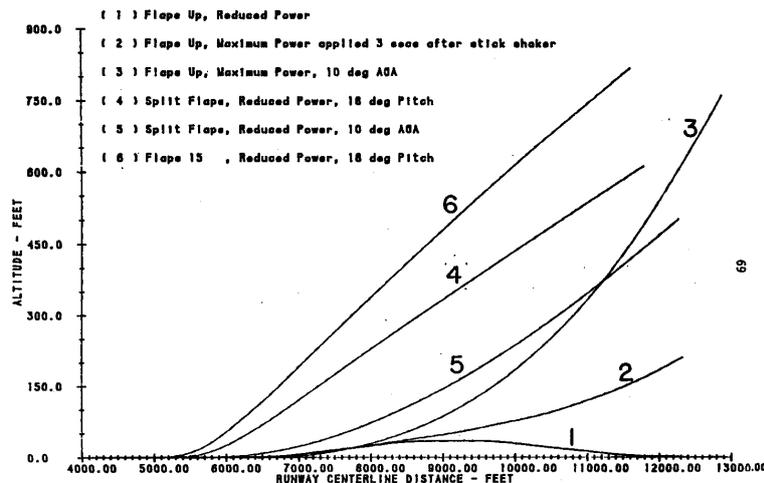
Figure 13.--Takeoff profiles.

The performance analysis, based upon the lift versus AOA data for the split flap configuration, indicates that had flight 1141 been so configured during the takeoff roll, the airplane's tail may have contacted the runway surface as the captain rotated to the takeoff attitude. However, the airplane, with its geometry-limited 10° pitch attitude would have lifted off at about 150 KCAS instead of the actual liftoff speed of 158 KCAS. A continued rotation at a rate greater than 1.5° per second would have resulted in stickshaker activation; but there would have been considerable margin to stall when the warning occurred and the airplane would have transitioned to a climbing flightpath with a vertical acceleration in excess of 1.2G. If the captain had ignored the stickshaker warning and continued to exert sufficient back force on the control column to raise the airplane's nose at a rate of 3° per second, the airplane would have achieved a 3° climbing flightpath at an AOA of about 15° within 2 seconds after liftoff. There would have been no airflow separation to explain the sudden roll of the airplane, and there would have been no engine inlet air turbulence to explain the compressor surges which were evident on the CVR. A more likely and proper flight crew reaction to the stickshaker activation would have been to relax the back force on the control column to silence the stickshaker, provided that that response would not result in a loss of critical altitude. Under such circumstances, the airplane would have continued to accelerate while developing sufficient lift force to transition to a climbing flightpath. These performance data indicate that about 10 seconds after

liftoff, the airplane would have been about 100 feet above the ground and climbing at about 1,200 feet per minute. The stickshaker would have activated only momentarily.

The Safety Board concludes that the actual performance of flight 1141 is not explainable by the "split flap" theory. A possibility that one flightcrew member reacted to the delayed liftoff and stickshaker onset by intentionally or inadvertently retracting the flaps to 0° is also implausible, since the 20 seconds required for the trailing edge flaps and leading edge devices to retract with consequent effect on flight performance would place the airplane far beyond the point at which the roll instability and engine compressor surges actually occurred. If the flaps retraction sequence had started at rotation, the airplane would have had sufficient lift to climb several hundred feet prior to the flaps reaching 0° . Furthermore, each of the flightcrew members positively stated that they did not reset the flap control lever after the takeoff was initiated, and that they knew of no situation in which they would have done so.
